Executive Summary

The expansion joints on the A702-20 Clydes Rail Bridge, which carries the A702 over the West Coast Mainline, run at a skewed angle across the carriageway. The joints are mechanical BEJ 8 joints, last replaced in 2012.

1 Introduction

2 Risk Assessment

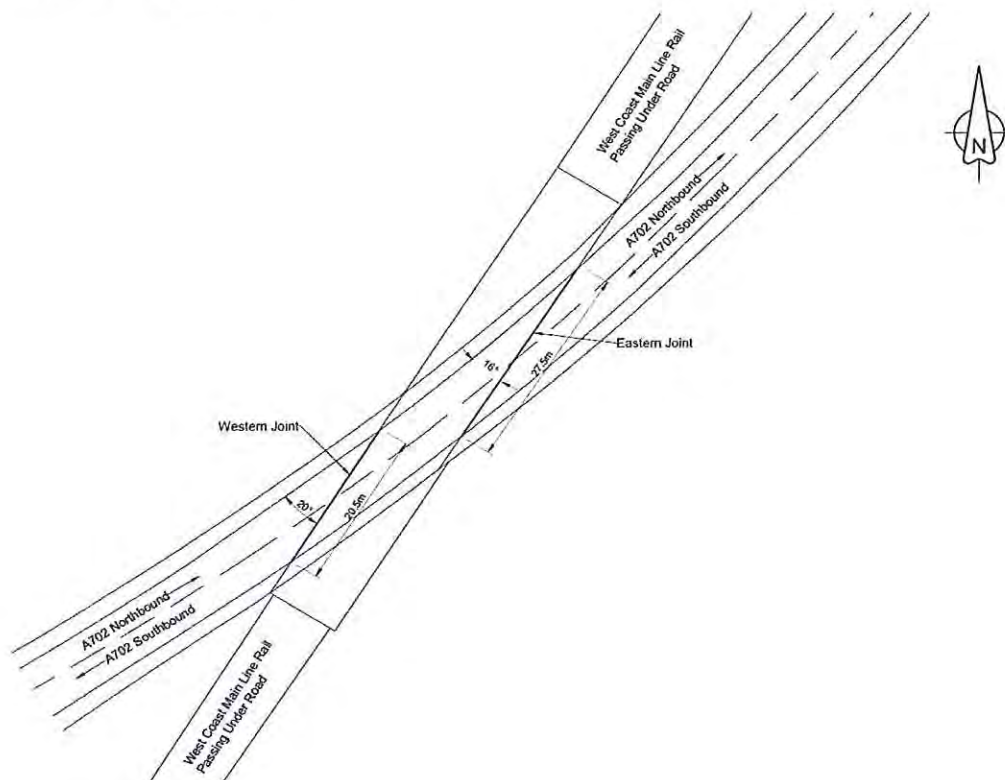
Figure 2: General Arrangement of site

The angle at which the road crosses the train line results in both joints aligning at different skewed angles to the carriageway. The western joint forms an angle of approximately 20° to the edge of the carriageway and is approximately 20.5m in length. The eastern joint forms an angle of approximately 16° and is approximately 27.5m in length, see Figure 2: General Arrangement of site.

- The angle of alignment between this joint and the edge of the carriageway is the smaller of the two joints, 16°, resulting in this joint being the most closely aligned with the direction of travel.
- Travelling northbound over the eastern expansion joint the cyclist would be entering a left hand turn as they left the bridge; this increases the alignment of the direction of travel with the angle of the joint. In comparison, travelling southbound over the same joint the cyclist would be exiting a right hand turn onto the bridge, therefore reducing the alignment of their wheel with the joint as they crossed it, refer to Figure 2: General Arrangement of site.

The angle between the edge of the carriageway and the line of the joint on the western side of the bridge is 20°, which is greater than the angle on the eastern side of the bridge, see Figure 2. The crossing of the western joint heading northbound occurs on a generally straight section of carriageway, maintaining the angle between the direction of travel and the line of the joint at 20°. The overall layout and approach to this joint, compared to that for the Northbound Eastern Joint, either reduces or maintains the risk level posed to the cyclist by the skew of the joint or the possibility of slipping on the rails to a Low/Medium level. Therefore any solution proposed for hazards assessed on the Northbound Eastern Joint would be considered sufficient for the Northbound Western Joint.

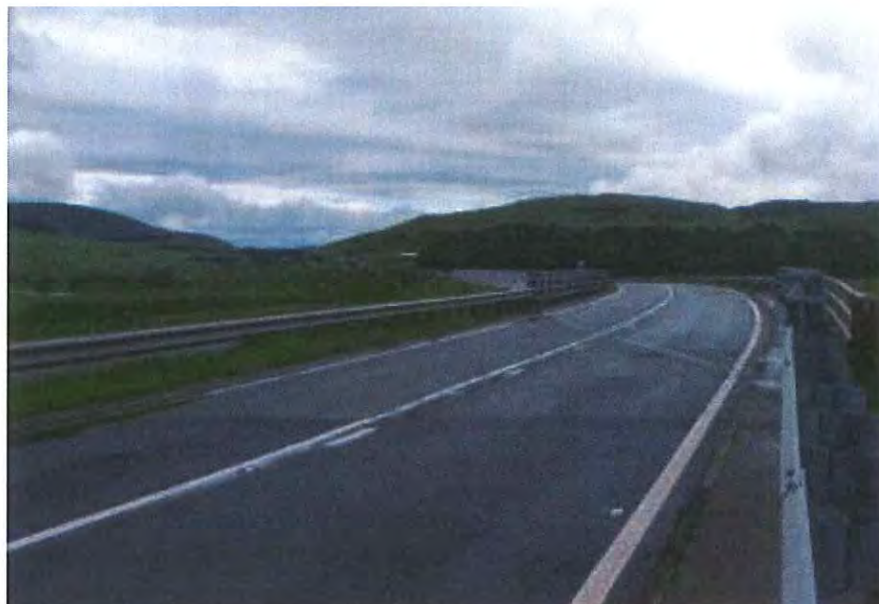
The bridge has two expansion joints, one at either end of the bridge. These joints follow the line of structure below the carriageway and are therefore running at a skewed angle across the carriageway, see Figure 4: Looking North East across the structure, from the western end of the southbound carriageway. and Figure 5 of Appendix A. The joints are mechanical BEJ 8 joints, replaced in 2012, by BEAR Scotland.

Figure 4: Looking North East across the structure, from the western end of the southbound carriageway.

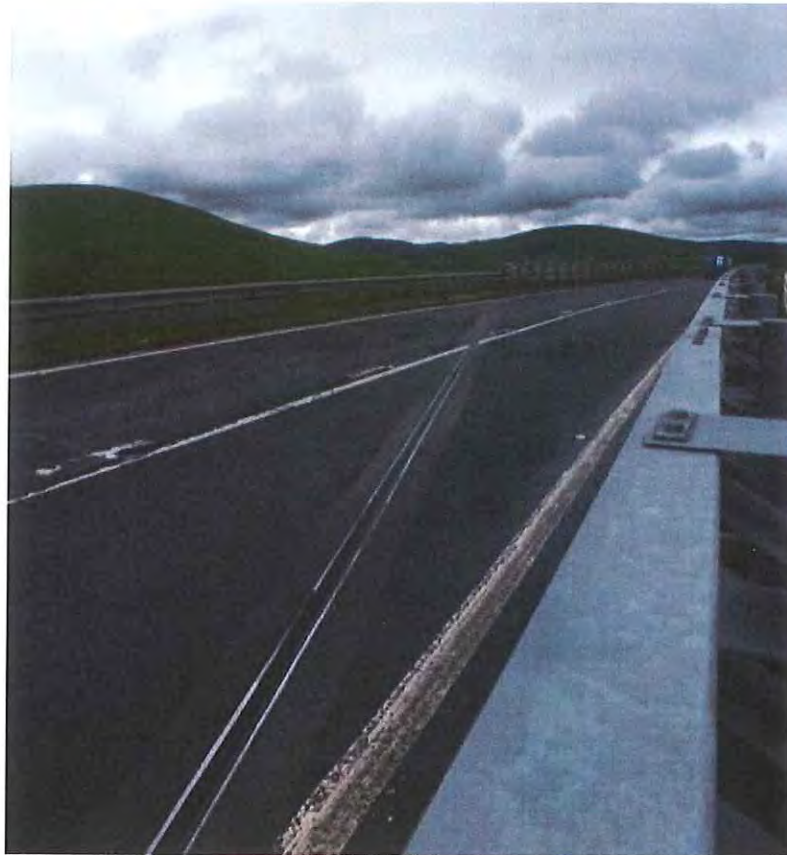
Figure 5: View of Eastern Joint – Taken from edge of Northbound carriageway looking South-West

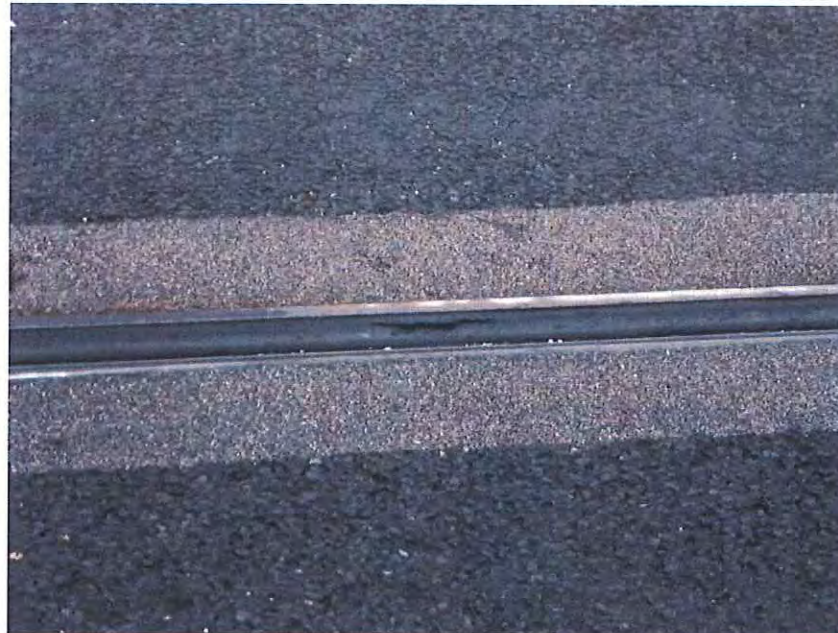
Generally the joints appear in a good condition. Some wear was noticed on the southbound carriageway eastern joint in the form of a slight tear in the seal; see Figure 6 in Appendix A. However in order to establish the true condition of the joints a full inspection, under traffic management and with access to the underside of the bridge, would be required.

Some wear was noticed on the existing seal of the eastern joint, on the southbound side of the carriageway. While a full investigation would be required in order to fully analyse the condition of the existing joints, the wear on the seal could be an indication of the seal beginning to fail. Replacing the seal of the joint may therefore extend the life cycle of the existing joints.

Figure 6: Tear on Eastern Joint Seal

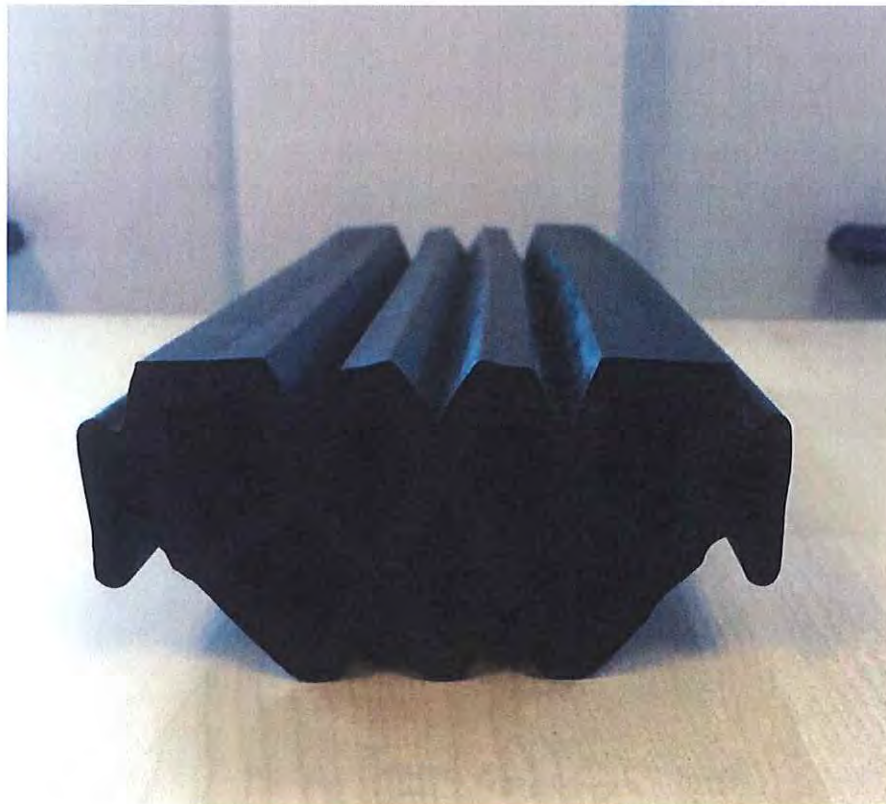
Figure 8: Proposed new BEJ seal profile – under development.

Proposed Mitigation: **New Seals** - Replacing the existing joint seal, see Figure 7 of Appendix A, with a new joint seal profile, see Figure 8 of Appendix A, which is currently being developed by USL.

Advantages of Mitigation: This new profile reduces difference in the level of the top of the joint rails and the level of the lowest point on the top of the seal. This would reduce any risk of bike road tyres getting wedged within the

The new seal profile can be installed into the existing rails, reducing the amount of work and time required to carry out the works, compared to the full replacement of the joints.

In order to remove the risk to cyclists using the bridge the recommended solution is to replace the existing joint seals with new seals currently being developed by USL. This solution is pending the results of the analysis of the next batch of joint seal samples to be obtained by USL by the end of September. These seals reduce the difference in level between the joint rails and the top surface of the seals. In doing so they remove the risk of a bicycle tyre wedging in the joint even if the tyre aligned with the line of the joint. The new seal can be installed into the existing joint rails, minimising the amount of disruption from required traffic management as well as minimising the costs involved in the works compared to replacing the full joint.
