Subject: Aberdeen Offshore Wind Farm Ltd_Dropped Objects Form_South Cardinal Buoy

OFFSHORE WIND & MARINE RENEWABLES DROPPED OBJECTS FORM

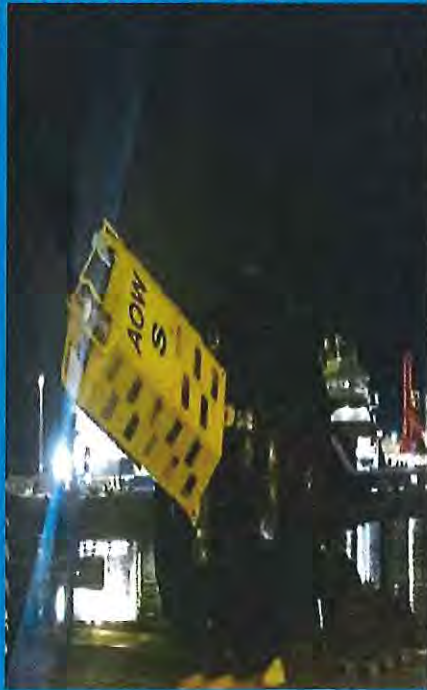
Picture on left is of actual South Cardinal Buoy

The cause of incident was most likely failure of the chain or connection which held the clump weight to the mooring chain for the buoy

In order to be able to redeploy the south cardinal buoy as soon as possible, and due to current vessel availability, the lost clump weight is proposed to be left in situ, while the cardinal buoy with the new clump weight is redeployed. However, it should be noted that all five clump weights used for construction buoyage will be removed following final commissioning of the construction marking for the Wind Farm.
