Aberdeen Offshore Wind Farm

Subject: Aberdeen Offshore Wind Farm Ltd_Dropped Objects Form_Track Pads (Trenchformer)

OFFSHORE WIND & MARINE RENEWABLES DROPPED OBJECTS FORM

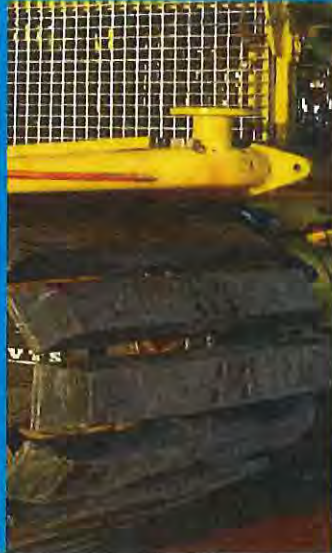
Trenchformer encountered rocky outcrops on the cable lay route which damaged or broke the track pads and it were lost. The trackpads are made of NYRIM (thermoplastic)

4 x Tracks were lost -Length: 80 cm m width: 19 cm height: 9 cm

Picture on left is of tracks intact on Trenchformer

Due to the nature of the track pads (not metallic) and their size they will be very hard to locate and recover. This would most likely require divers and AOWFL believes that this would impose a high risk from a Health and Safety point of view. Outweighing the benefits of this recovery versus the risk associated, AOWFL proposes to leave them in situ.

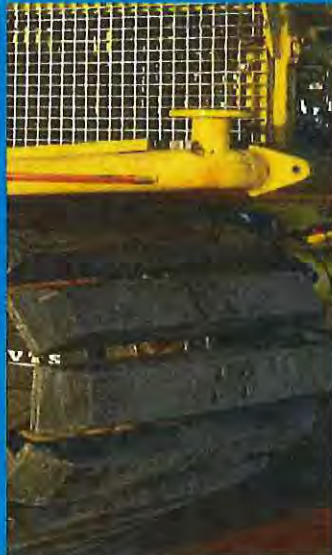
Trenchformer encountered rocky outcrops on the cable lay route which damaged or broke the track pads and it were lost. The trackpads are made of NYRIM (thermoplastic).

4 x Tracks were lost -Length: 80 cm m width: 19 cm height: 9 cm

Picture on left is of tracks intact on Trenchformer

Due to the nature of the track pads (not metallic) and their size they will be very hard to locate and recover. This would most likely require divers and AOWFL believes that this would impose a high risk from a Health and Safety point of view. Outweighing the benefits of this recovery versus the risk associated, AOWFL proposes to leave them in situ.
