## Glen Sannox & 802 Monthly Report – [July 2022]

## Owners' Observation Reports 801

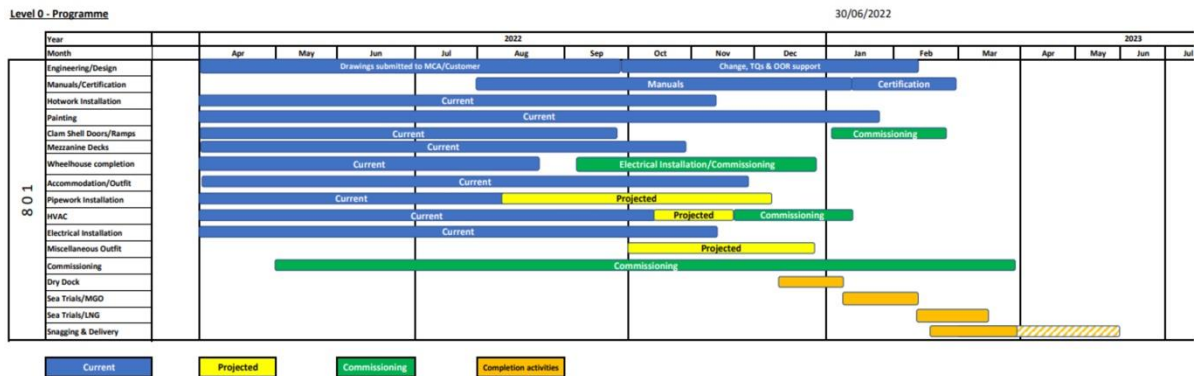
### Level 0 Programme

The 801 project is making progress toward its objectives. However, completing background outfitting and pre-commissioning activities remains intensely time-consuming.

Commissioning has commenced and is moving in the right direction, although the start is much slower than planned.

The total float of the project and how it relates to the critical path must now be carefully managed especially during the three-week docking period.

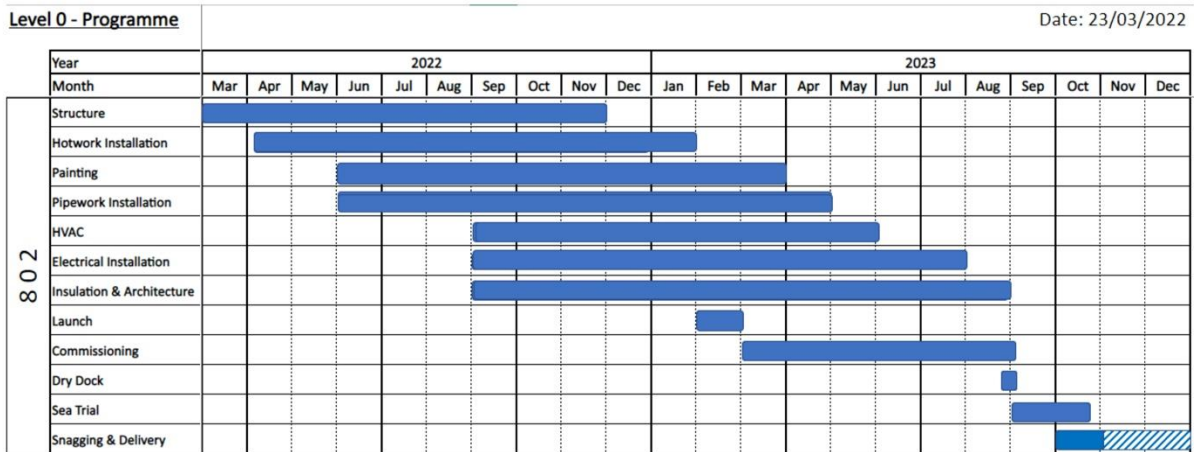
### 802 Cardinal Date Programme

The majority of work focus remains structural, higher levels of outfitting await the outcome of the detailed model review that completed week 32.

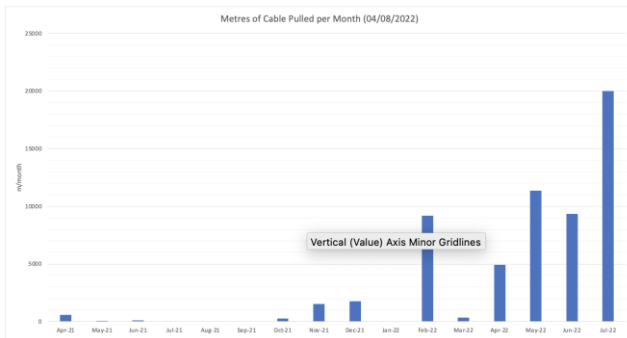
Cable pulling has continued throughout the vessel in both the machinery and passenger accommodation areas. The shipyard reports that circa 60,000m of cable has been installed out of a total of 242,856m, representing a 26 percent completion level. Although the meterage of installed cabling has increased this period the planned level of percentage complete should be up around 65 percent. The impact of this delay is significant as it effects almost all completion works throughout the vessel.
