Expansion Joint Options Report

A702 20 Clydes Rail Bridge – Expansion Joints Refurbishment

15/SE/1201/032-02 Revision 01

Expansion Joint Risk Assessment A702-20 Clydes Rail Bridge

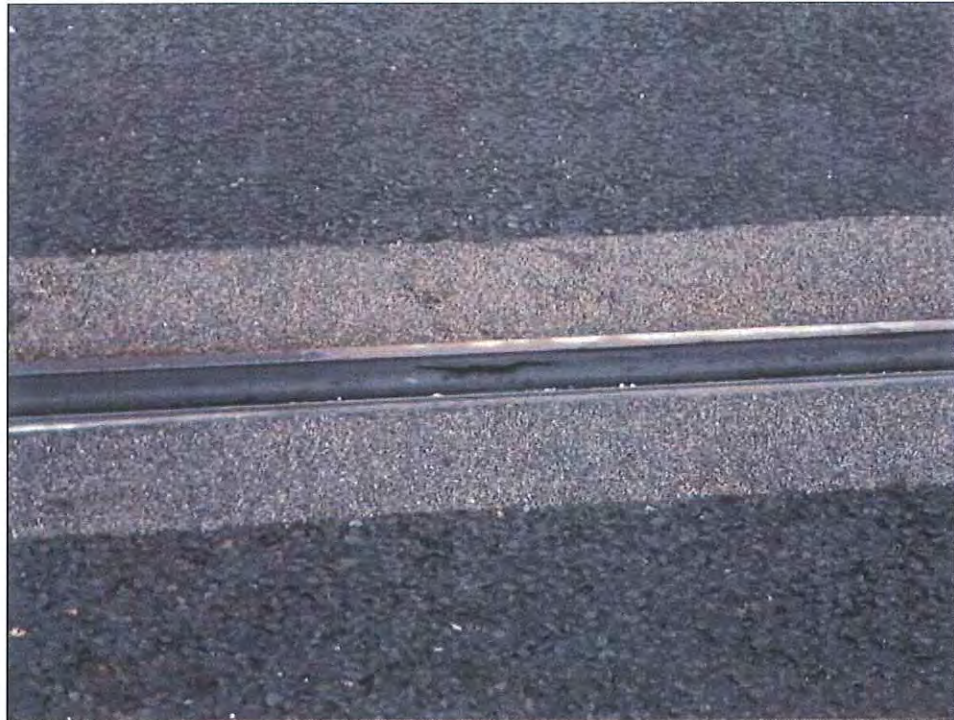
Figure 2.1 – Joint Seal Tear

From inspecting the existing joints at carriageway level, they appear to be in generally good condition. However, there is a small tear present on the seal of the east joint (see Figure 2.1). It is not possible to determine whether there is any leakage through the existing joints without gaining access to the railway track.

It is recommended to replace the existing expansion joints with high modulus Permatrack H Plug joints at this structure. Through reviewing different joint options, the Permatrack system is the only HA approved system that completely removes the entrapment hazard to cyclists with literature that states it can be installed at any depth and width. The literature also states that the PSB layer and strip effectively isolates the asphalt from skew movements. RAB Associates, with 15 years of Permatrack development and installation experience, recommend the use of the Permatrack H system for highly skewed joints based on Permatrack’s excellent record in its additional use for both transverse and longitudinal crack repairs on highways, where it is subject to high stresses and shearing. Additionally RAB guarantee the installation of the Permatrack H Joint for 10 years (subject to normal exclusions regarding misuse and/or accidental damage caused to the joint). See Figure 3.1 for a cross-section of the Permatrack H Plug Joint Design.

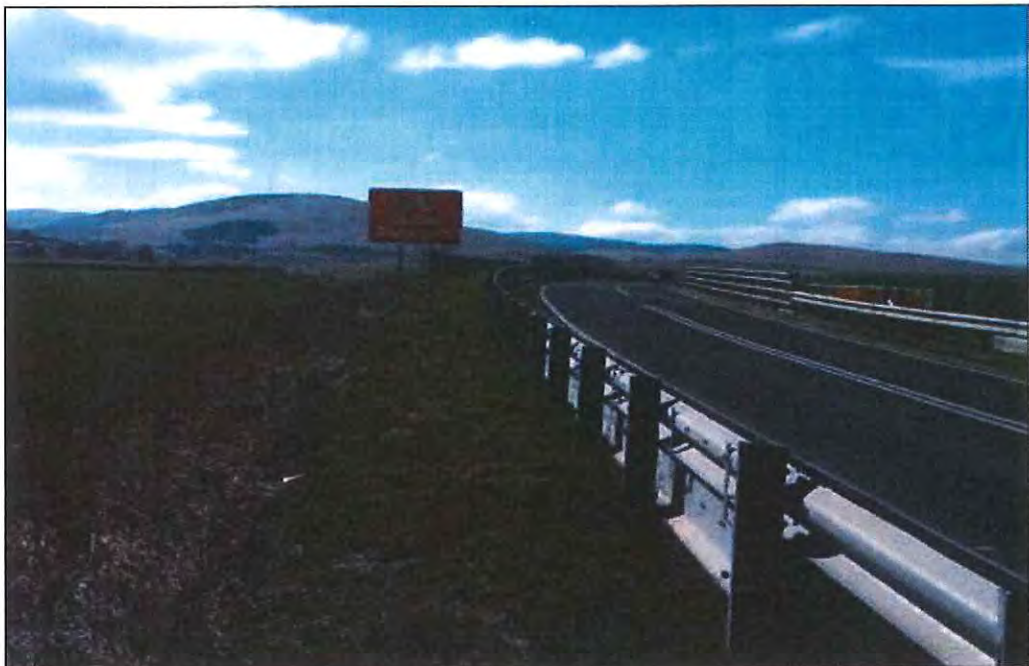
Figure 2.2 – Expansion Joint Warning Signs

Following on from a risk assessment of the site, prepared by Amey and submitted to Transport Scotland in September 2015, warning signs have been installed at both ends of the structure warning cyclists of the presence of the joints (see Figure 2.2).

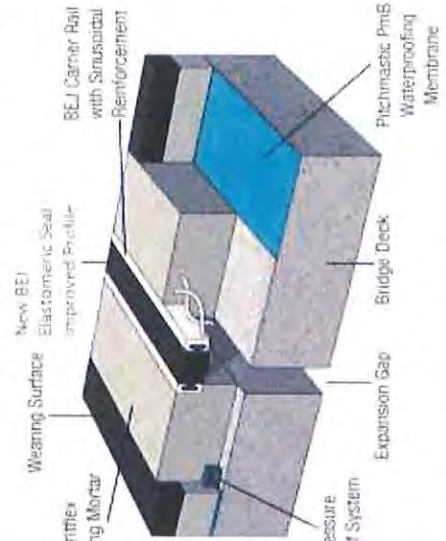
<p>Figure 2.4 - BEJ Rail Joint with improved Elastomeric Seal Profile – Still in development.</p>	USL	<p>1) Removes entrapment hazard to cyclists.</p> <p>2) Utilizes existing rails which are in good condition.</p>	<p>1) Seal currently in an early development stage with no certain timescales for completion and no guarantee of an end product.</p> <p>2) Not a HA Registered Product</p>
<p>FEBA (APJ) Joint.</p>

As recommended by the risk assessment report, Amey have been liaising with USL regarding their ongoing development of a new rubber seal profile for use in mechanical joints. This seal, once developed, has the potential to replace the existing joint seals, reducing the difference in level between the top surface of the joint rails and the top surface of the seal. In doing so this would remove the risk of a bicycle wheel becoming entrapped in the joint. Test results on the new seal have not been favourable and it is uncertain when a suitable product will be available.

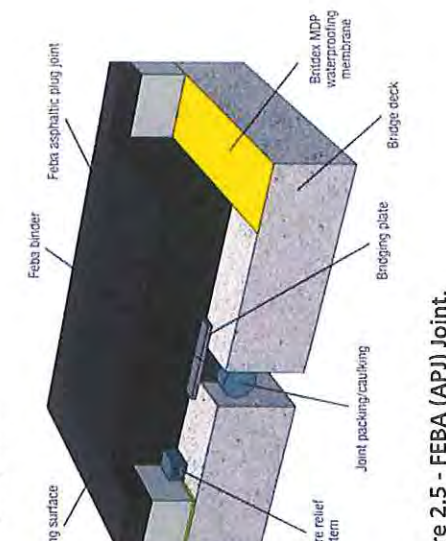
<p>Figure 2.5 - FEBA (APJ) Joint.</p>	USL	<p>1) Removes entrapment hazard to cyclists.</p> <p>2) HA Registered Product</p>	<p>1) Rarely installed on a skew as it is subject to rutting and splitting as a result of the increased trafficked width of the joint.</p>

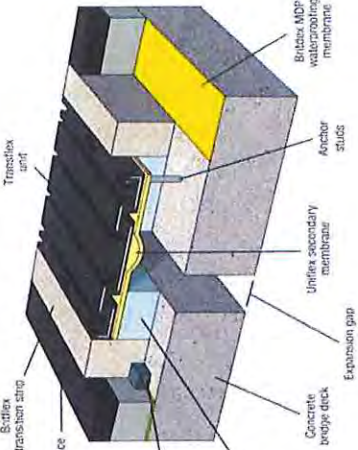
<p>Figure 2.6 - Transflex Joint.</p>	USL	<p>1) Performs better on a skew than traditional APJ joints.</p> <p>2) HA Registered Product.</p>	<p>1) Does not remove entrapment hazard to cyclists.</p>
<p>Brittflex NJ (Nosing with Preformed Compressed Seal) Joint.</p>

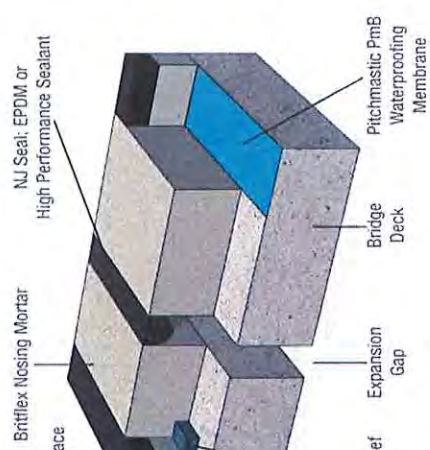
<p>Figure 2.7 - Brittflex NJ Joint.</p>	USL	<p>1) Performs better on a skew than traditional APJ joints.</p> <p>2) HA Registered Product.</p>	<p>1) Reduces but does not remove entrapment hazard to cyclists.</p>

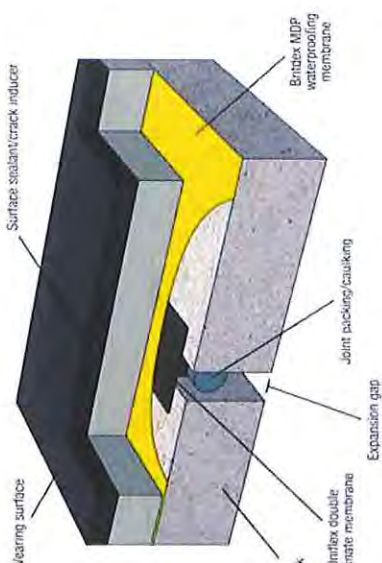
<p>Figure 2.8 - Buried Joint</p> <p>Various other companies have their own APJ and rail and seal options. However, these have the same limitations as a traditional APJ in terms of being installed on a skew and their seals tend to have similar profiles which do not remove the entrapment hazard to cyclists.</p>	-	<p>1) Joint itself is buried so not directly loaded by traffic.</p> <p>2) Greatly improves water migration over the joint instead of sub-surface ponding associated with alternative systems.</p>	<p>1) The bridge deck surface or waterproofing does not require an entire replacement at this stage. Therefore, the road surface would have to be removed and reinstated locally to where the buried joint is installed most likely over a 5m length and full width of the structure. The joints in the road surfacing and a lack of continuous waterproofing along the base may cause the expansion joint to be vulnerable to water leakage in the future.</p> <p>2) Damage to adjacent systems not intended for replacement would be at risk.</p>
